Levee failure mechanisms during the extreme rainfall event: a case study in Southern Taiwan

Wen-Chao Huang · Meng-Chia Weng · Ray-Kuo Chen

Abstract Extreme weather has recently caused many disasters worldwide. In August 8, 2009, Southern Taiwan suffered from serious floods during Typhoon Morakot. In this extreme rainfall event, the Chiuliao first levee in the Laonong River basin experienced catastrophic failure. Therefore, this study focuses on the levee failure mechanisms based on variations in levee water levels. Specifically, this study investigates four mechanisms based on limit state equilibrium. The first mechanism involves the slope stability under hydrostatic conditions at various water levels. The results of this analysis show that the levee cannot fail under this mechanism. The second mechanism involves the levee slope stability with steady-state seepage. Because the water levels are different on the protected and flood sides, the water recedes much faster on the flood side than the protected side. Based on this analysis, the levee slope might fail when the water level at the protected side is close to the top of levee and the water level at the flood side starts to rec

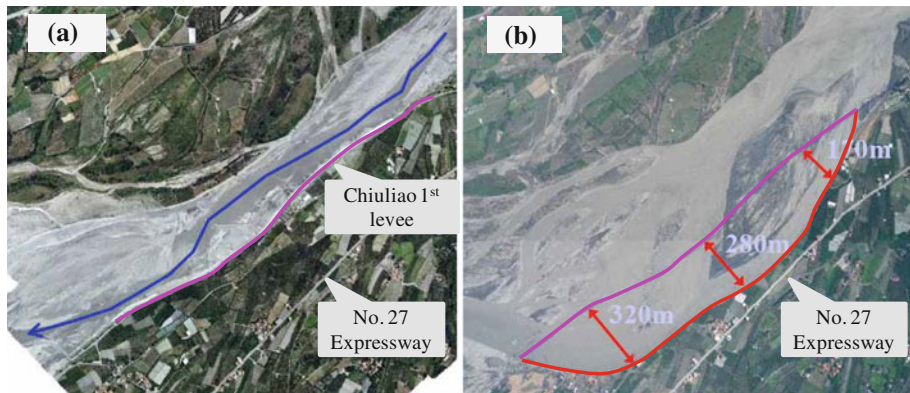
Among the levee breaches above, the most serious disaster occurred at the Chiuliao first levee, which is located in Kaoshu village in Pintung County (No. 6 in Fig. 1). This levee was built on the left river bank near the confluence of the Laonong River and its branch, the Chokuo River. This levee is a gravity-type earthen levee with a height of approximately 10 m. During Typhoon Morakot, approximately 4,000 m of the levee broke away, providing an opening for water to scour the protected side of the structure (Fig. 2). Approximately 0.5 km² of agricultural area behind the levee was eroded and more than 20 houses were destroyed (Figs. 2, 3) (Li et al. 2009; Liu et al. 2009; Chang 2012). This event drew significant public attention to the issue of levee safety.

Fig. 2 Aerial photographs of the Chiuliao first levee breach before and after Typhoon Morakot. The breach length is approximately 4,000 m, and the maximum side erosion is approximately 320 m (Chang 2012). **a** Before Typhoon Morakot; **b** after Typhoon Morakot

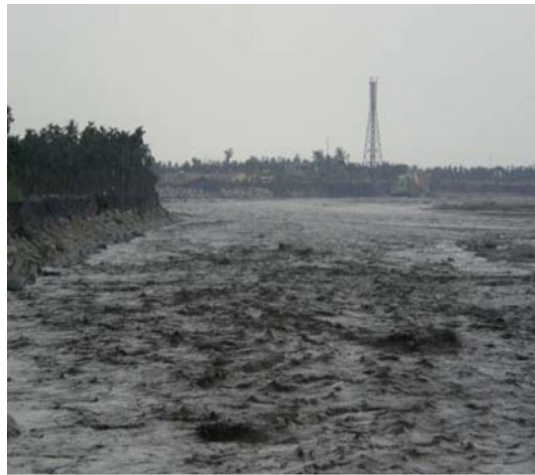
(a)

Fig. 3 Field investigation after Typhoon Morakot (Li et al. 2009). **a** Side erosion at the river bank; **b** collapsed building

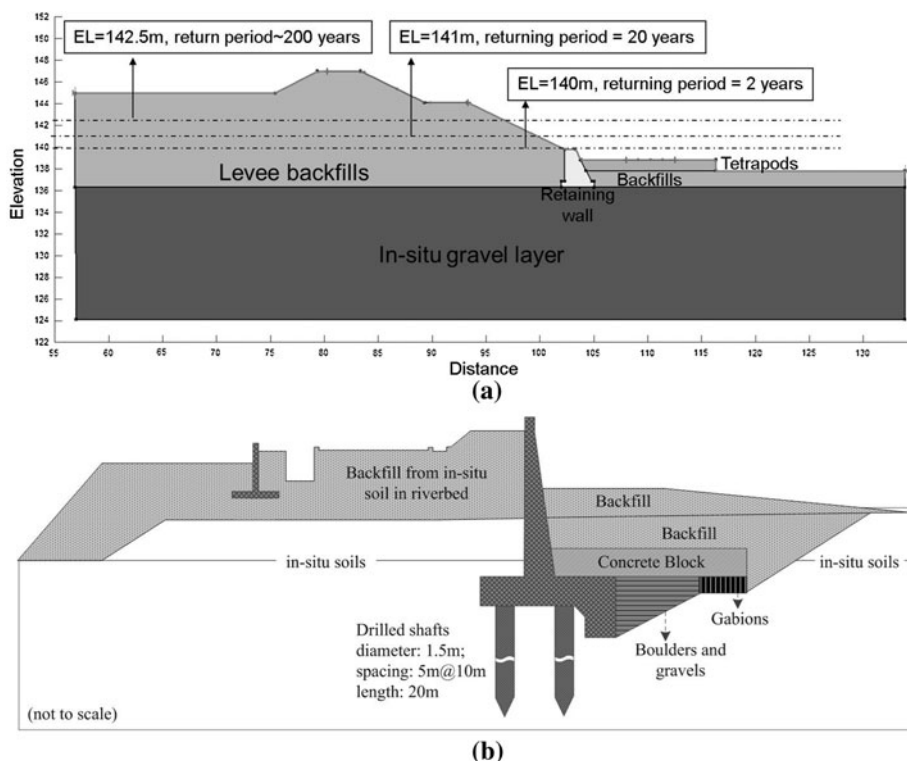
In addition to the in situ soil properties, we collected the design profiles of the levee before and after Typhoon Morakot to perform the relevant analysis of levee stability (Fig. 6). Before Typhoon Morakot, the levee foundation was constructed directly on the in situ soil layers, with a 1.5-m layer of backfill and a layer of rockfill to stabilize the flood side of the levee.

Conversely, the foundation of the levee is a key factor influencing the stability of the levee. As Fig. 6a shows, the original design of the levee foundation plays an important role in stabilizing the levee system. Once the foundation is destabilized because of external factors, such as scouring or water-level variations, the whole levee may become unsafe. For these reasons, we also analyzed the levee foundation at different scouring depths and water levels on the protected and flood sides. Scouring effect was considered in the slope stability analysis without seepage. In slope stability and retaining wall stability analyses coupled with seepage, due to the fact that the stability relies highly on the existence of passive resistance (water or passive forces), once the backfill was carried away, the loss of passive resistance could cause immediate failure of the retaining wall or slope stability with seepage. In this study, only a few cases of slope stability and retaining wall stability with seepage were considered with scouring under higher water levels, which correspond to a more critical state of the levee. This study does not consider the scouring effect for the

Fig. 6 Illustration of the levee profile of the Chiuliao first levee. **a** Levee profile before Typhoon Morakot; **b** design levee profile after Typhoon Morakot

Figure 6b shows the design cross section of Chiuliao first levee after Typhoon Morakot. Two rows of piles were added to the bottom of the cantilever levee foundation, and gabions and rocks were also added to the flood side of the levee to provide additional weight for stabilization. The application of rows of piles under the levee foundation might be able to resolve the possible failure mechanisms discussed in this study. Although further analysis regarding the new cross section has not been performed, these rows of piles can provide additional forces against sliding and overturning. The application of piles can also provide tension forces when a high water level causes a high pore-water pressure, which in turn induces uplift force that deteriorates the levee foundation. The application of piles can also force the potential slope failure surface to go down, increasing the safety factor against slope instability.

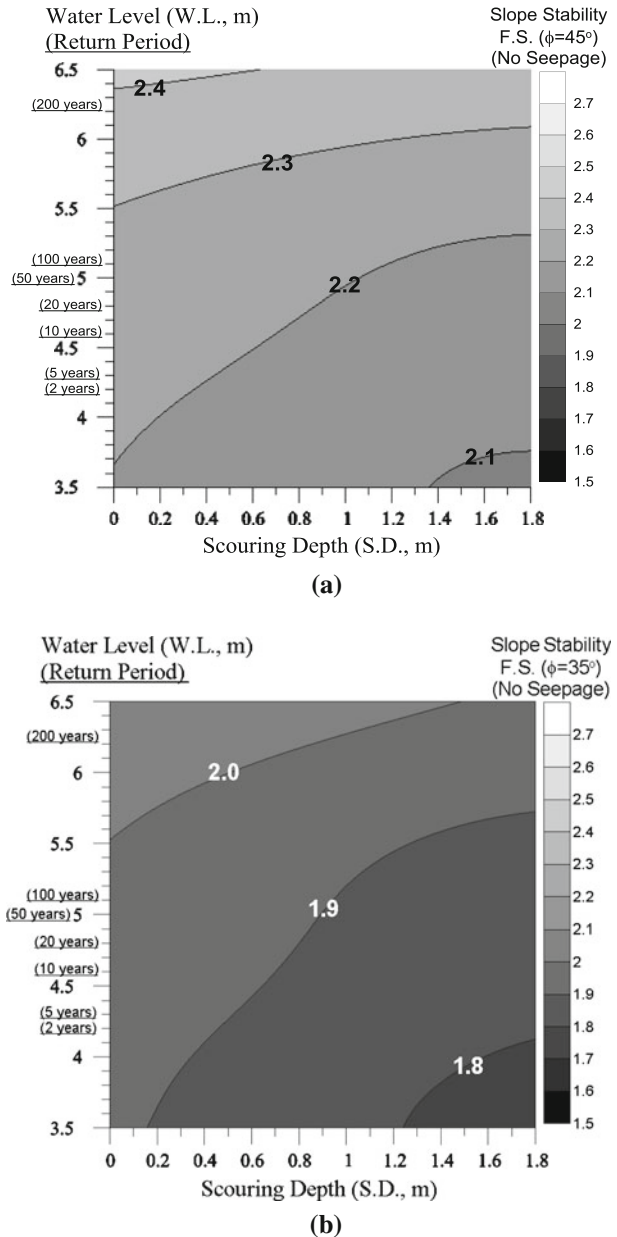
Figure 10 shows the variations in safety factor at different scouring depths and water levels. In Fig. 10, the water level was also expressed in terms of the flood returning period with friction angle of 45° and 35° . The analysis results show that as the scouring depth increases, the safety factor decreases, and as the water level increases, the safety factor also increases. This increasing safety factor with increasing water level is the result of increasing hydraulic pressure after the levee surface. Figure 10 also shows that the safety factors of all the analyzed cases are larger than 2 for both 45° and 35° , meaning that the

Fig. 10 Influence of scouring depth (SD) and water level (WL) on the stability of levee.
a $\phi = 45^\circ$; **b** $\phi = 35^\circ$

levee failure mechanism by slope failure with the same water level is less possible during an extreme weather event.

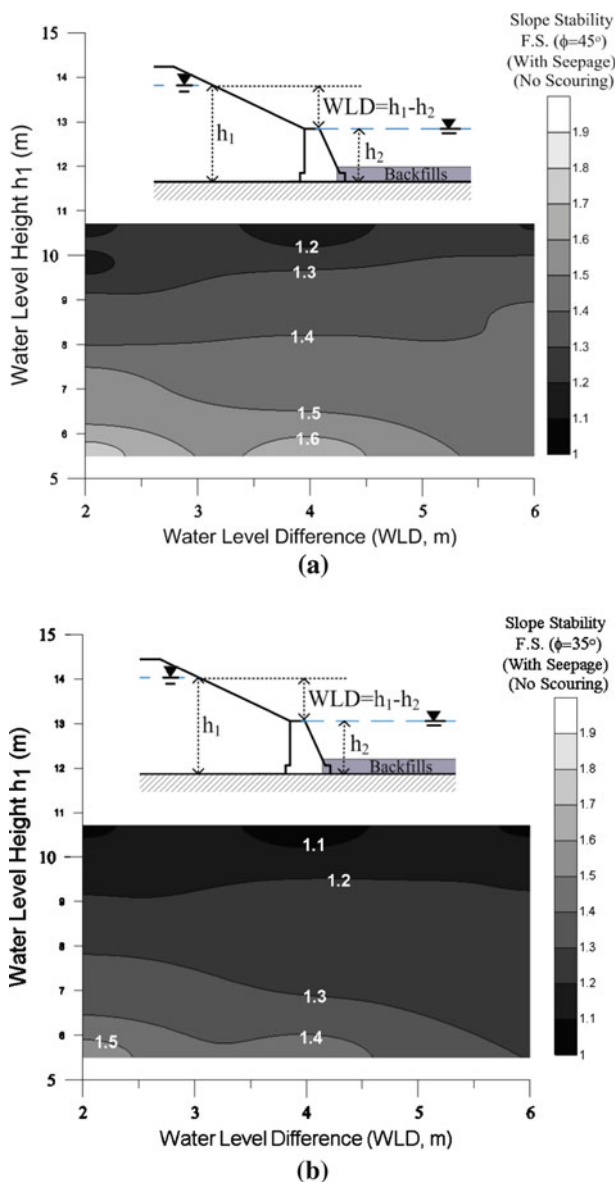
This study also considers the steady-state seepage with various water levels at two sides of the levees through the slope stability analysis (Fig. 11). This figure shows that the water level at the protected side is defined as h_1 and water-level difference is defined as protected side water level minus flood side water level. The flood water was clogged on the protected side such that the water only seeps from the protected side toward the flood side under the

Fig. 11 Influence of water-level height on the stability of levee (with safety factor calculated based on the slope stability coupled with seepage effect). **a** $\phi = 45^\circ$; **b** $\phi = 35^\circ$

levee foundation. Therefore, the water-level difference is always positive in this study. In addition, the results shown in Fig. 11 do not consider the scouring depth. Based on the slope stability viewpoint with steady-state seepage, the safety factor is more sensitive to variations in the protected side water level. For example, in Fig. 11a, when h_1 varies from 9 to 10.7 m, it causes a variation of safety factors from 1.1 to 1.3. For the same protected side water level, the change of water-level difference does not cause too much variation in

the corresponding safety factor. In addition, the sensitivity of the water-level difference toward the safety factor depends on the protected side water level. Figure 11a shows that when the water-level difference is a constant, the change of water level on the protected side caused a more sensitive response on the safety factor, especially when the water level is high. This indicates that a high water level on the protected side is itself a deteriorating factor that reduces the overall safety of the levee. When the protected side water level is close to the top of levee, the slope stability safety factor is in a critical range such that a small amount of water-level difference might cause levee slope failure. The input friction angle for the results shown in Fig. 11 is 45° , which is close to the upper bound of the analyzed friction angle. Figure 11b also showed the analyzed results under 35° of friction angle, which correspond to a lower bound value. Figure 11a, b can be employed to understand the possible outcomes under a lower and higher friction angles. From Fig. 11, it was found that the influence caused by a difference of 10° was not too significant in terms of the slope stability analysis.

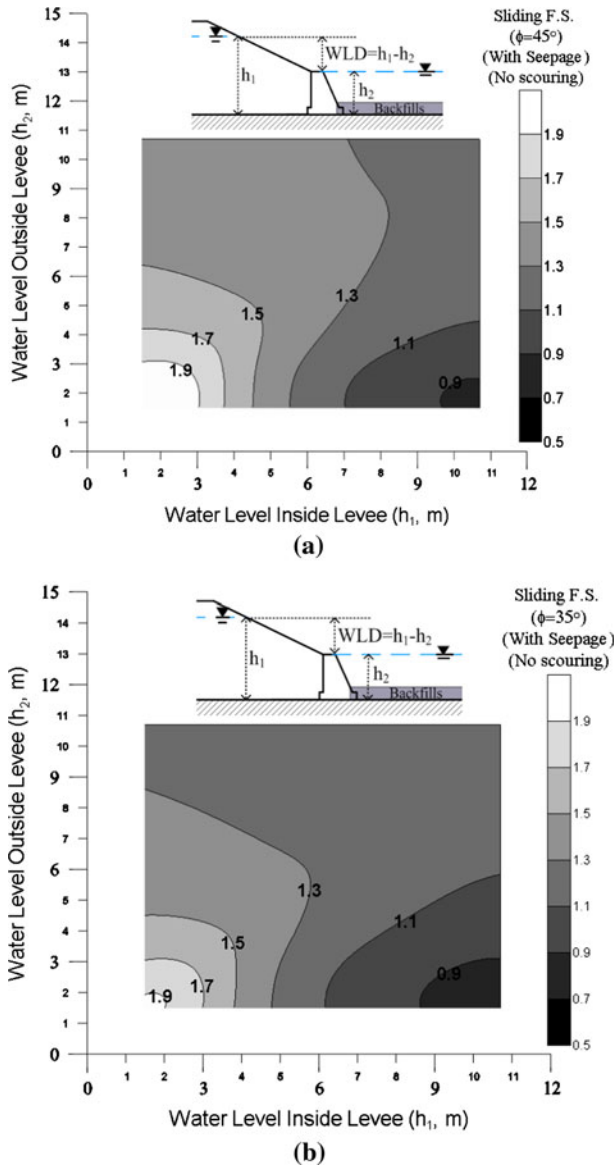
The results in Fig. 12 show the levee foundation stability against sliding with friction angles of 35° and 45° . These figures show that an increase in the water level on both the flood side and protected side decreases the stability against sliding. The increase in the water level on the flood side (h_2) is not as sensitive to the variation of protected side water level (h_1). When the flood side water level nears the top of the levee (i.e., reaches 9–10.7 m), the safety factor against sliding ranges from 1.2 to 1.4, but is not sensitive to a variation in water level on the protected side. The safety factor changes most rapidly in the following two conditions:

The safety factor changes most rapidly in the following two conditions. The first condition (Condition 1) indicates that levee is in a stable state when the protected side water level is between 3.5 and 4.5 m with flood side water level between 3.5 and 5 m. The second condition (Condition 2) represents a critical state of the levee. The critical state occurs at 6–10.5 m of the protected side water level and 1.5–6.5 m of the flood side water level.

The safety factors against sliding in Condition (1) are greater than 1.5, showing that the levee foundation is still in a stable state despite rapid variations in the safety factor. This is also reasonable because the water levels on both sides of the levee are in the lower range of the expected water level. Therefore, no failure is expected for this water-level range. In Condition (2), which shows a relatively high water levels at both sides of the levee, the corresponding maximum safety factor is about 1.3, which is an acceptable value against sliding. However, as the water level on the flood side starts to recede, the safety factor starts to decrease to a value of approximately 1–1.1 when the water level on the flood side changes 4–5 m. This is a critical failure state for the levee foundation, which may undergo sliding failure.

Fig. 12 Influence of water level on sliding safety factors of the levee foundation with different friction angles. **a** $\phi = 45^\circ$; **b** $\phi = 35^\circ$

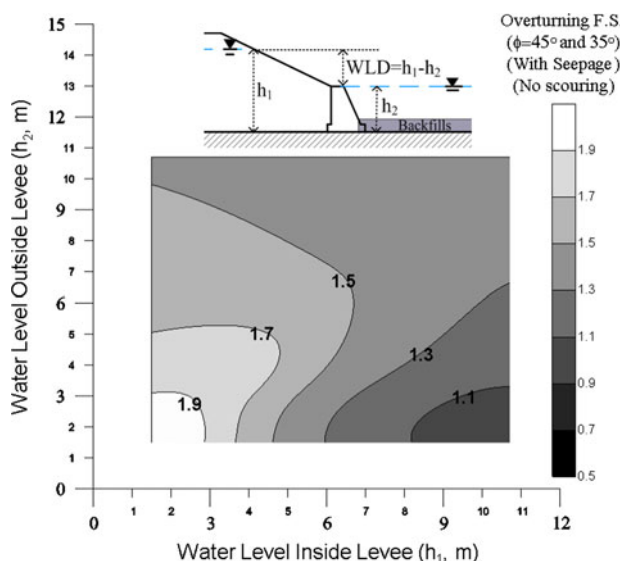
Figure 13 shows the variation of water levels and the corresponding variations of safety factor against overturning failure. A similar trend here is that the safety factor against overturning is more sensitive to water-level variations on the protected side than the flood side. Similarly, when the flood side water level is close to the top of levee, the corresponding safety factor is always greater than 1.3. The overturning failure considered in this study is when the levee foundation overturns toward the flood side. Therefore, when the flood side water level is high, it provides an additional stabilization moment against overturning failure. Another extreme situation is when the protected side water level is close to the top of levee. When the flood side water level has receded, the corresponding safety factor against overturning reaches 1.1–1.2. Then, the water level on the protected side ranges from 6 to 10.7 m and the flood side water level ranges from 3 to 5 m; the overturning safety factor is not acceptable, with a value always smaller than 1.2.

A comparison of the levee foundation failure modes between sliding and overturning shows that the analyzed levee foundation is more prone to sliding failure than overturning failure. Analyzing the same water-level scenario for both sliding and overturning failure shows that the sliding safety factor is always smaller than the overturning safety factor. Under extreme water-level conditions, when the protected side water level is close to the top of the levee and the flood side water level recedes to a relatively low level, the corresponding safety factor for sliding is even smaller than the safety factor for overturning

Fig. 13 Influence of water level on overturning safety factors of the levee foundation with different friction angles

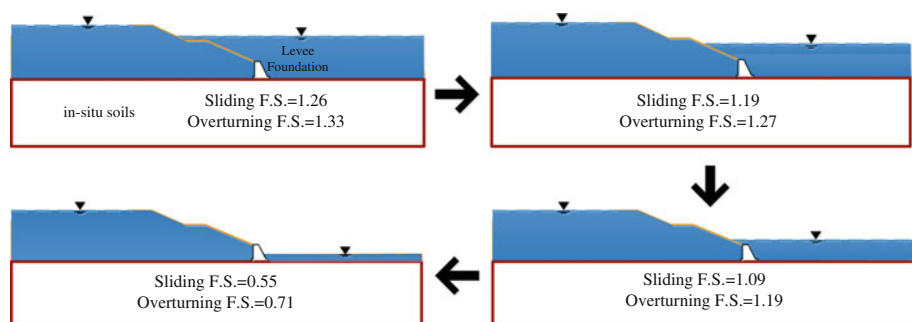
As shown in Fig. 14, the failure of the Chiuliao first levee might involve two major mechanisms. The first mechanism is the slope failure under steady-state seepage. The second mechanism is the levee foundation sliding failure, which causes possible sequence for the levee to reach failure state. As the water level increases on both sides of the levee,

Fig. 14 Analyzed safety factors (the first safety factor represents the sliding safety factor and the second represents the overturning safety factor) under various water-level situations with in situ $\phi = 45^\circ$ (only tripod rocks were assumed to be carried away)

the safety factor remains acceptable until the water levels reach the top of the levee. If the water mass remains on the protected side while the water on the flood side recedes, both the levee slope and the levee foundation may fail because of the water-level difference. Although a high water level is one of the possible mechanisms triggering failure, other mechanisms might be more likely to be triggered under more critical water-level situations. It is also to be emphasized that the results reported in the figures or table do not take into consideration the scouring depth, due to the fact that once scouring was analyzed with the corresponding failure mechanism, all of the safety factors become even smaller. Hence, all of the safety factors might become smaller when scouring occurred in the field.
